PHASE I

MAY 2013

DARBY BOROUGH

GRADE CROSSING STUDY

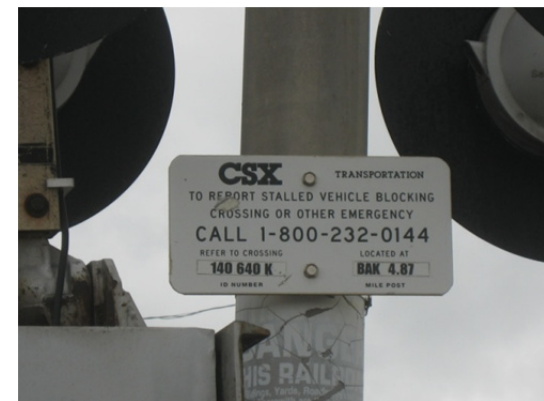
The Crossing ID placard at the Fifth Street grade crossing (#140640K) in Darby, PA. (Source: DVRPC)

The crossing numbers are useful for reporting an incident or maintenance concern at a grade crossing. Each grade crossing should be equipped with placards that display this number, along with a phone number for the railroad that owns the rail line.

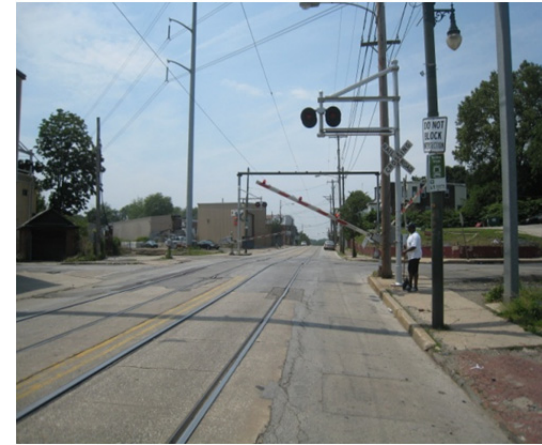
The gates closing for an oncoming train at the Main Street grade crossing (facing west). (Source: DVRPC)

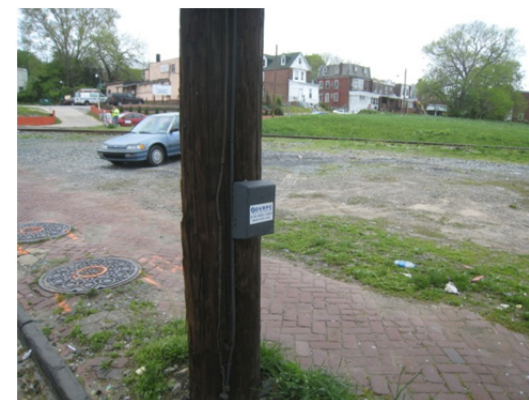
*An automated pedestrian counter on the north side of Main Street.
(Source: DVRPC)*

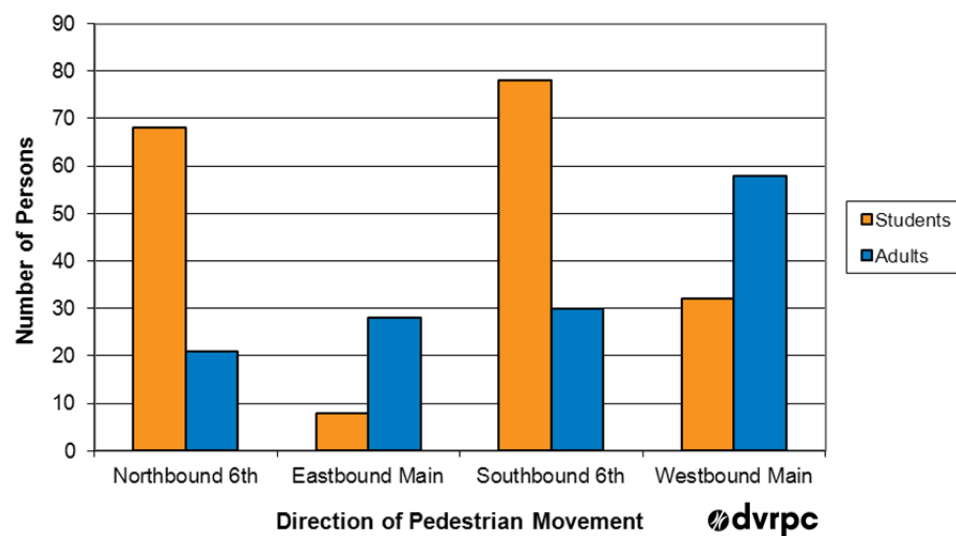
Figure 4: Total Number of Pedestrians during the Morning Peak Hours (7:00-9:00 AM)

Figure 4 displays the number of pedestrians by their direction of movement away from the Main Street grade crossing. This illustrates which students are going toward the Penn Wood Middle School and which are going toward the Walnut Street Elementary School. Students (shown in orange) exiting the grade crossing going southbound on Sixth Street are almost exclusively elementary school students, while students exiting the intersection traveling northbound on Sixth Street are almost exclusively middle school students. While middle school students may take a bus to get to school, many choose to walk instead. There is a grade-crossing guard positioned at the corner of Sixth and Main Street during both the morning and afternoon to guide children safely across the intersection, and thus the grade crossing as well. A significant portion of persons going westbound on Main Street use the Route 11 trolley stop for eastbound trolleys to Philadelphia.

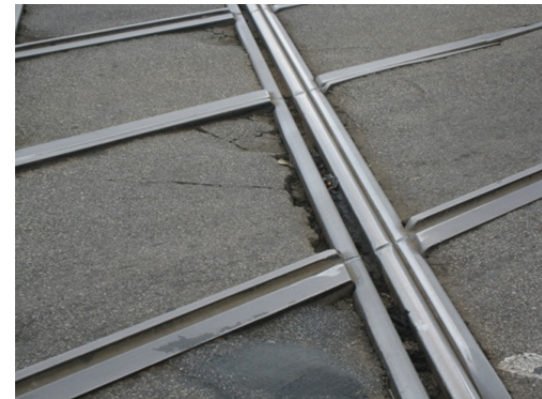
Recently, double-frogged flange, was installed at the Main Street grade crossing. The trolley tracks are situated at a slightly higher elevation than the railroad tracks. This allows the trolley to virtually pass over the rail line without making as much contact and without creating as much wear and tear on the surrounding pavement. While the double-frogged flange has

*A close-up of the grade crossing surface on Main Street in Darby Borough.
(Source: DVRPC)*

provided some improvements, the surrounding pavement is still deteriorating and will still need regular maintenance in the future. This regular maintenance is expensive, and any major project at the crossing should seek to continue to improve the surface conditions.

At Main Street, frequent resurfacing of the crossing has been necessary due to the additional wear and tear caused by trolley traffic. While the new double-frogged flange has been a major upgrade over the previous crossing mechanism, new technologies may be discovered that provide an even better solution. Additionally, a new water drainage system for the crossing and the surrounding roadway and railroad bed has the possibility of lessening future maintenance needs and making the area around the crossing more visually appealing. At Fifth Street, the resurfacing could focus on the roadway leading up to and proceeding away from the crossing to create a smoother change of grade instead of the severe ramp that currently exists on either side.

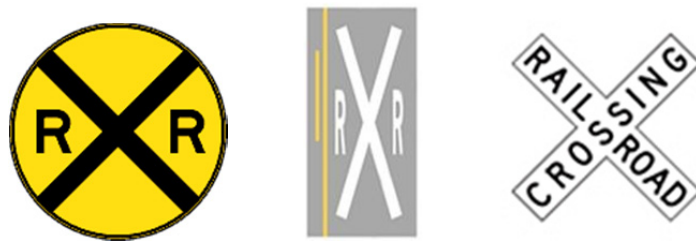
Figure 10: Examples of Popular Passive Warning Devices

Left: An Advanced grade crossing warning sign.
Center: Advanced grade crossing warning striping in pavement.
Right: Grade crossing cross bucks.
(Source: Operation Lifesaver)

Passive Devices refer to the signage and striping at a grade crossing and the advanced signage and striping leading up to a grade crossing. In many rural areas or on seldom-used rail lines, passive devices are the only safety measure present at a grade crossing. Advanced passive devices play an important role in warning vehicular traffic, which is especially important for drivers unfamiliar with the area. Passive devices at a crossing usually consist of a cross buck railroad sign and striping to let motorists know exactly where the train crosses.

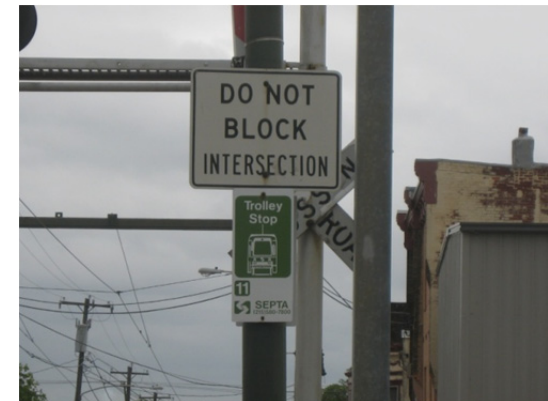
Above: A cross buck sign is obscured by a "Trolley Stop" sign and "Do Not Block Intersection" sign on the eastbound approach to the grade crossing on Main Street. (Source DVRPC)

All signage at the Main Street grade crossing and advanced signage leading up to the Main Street crossing could be replaced with new passive devices. When placing the signs, it is important to have sufficient sight distance and visibility so that the signs can be easily seen. Striping could be improved at the crossing by providing advanced warning signs. Stop bars should be

refreshed well before the crossing gate on Main Street. Currently, the stop bars on eastbound Main Street bisect the train tracks. At Fifth Street, the posted cross bucks are clearly visible, but there are no advanced warning signs or striping in the pavement to warn drivers.

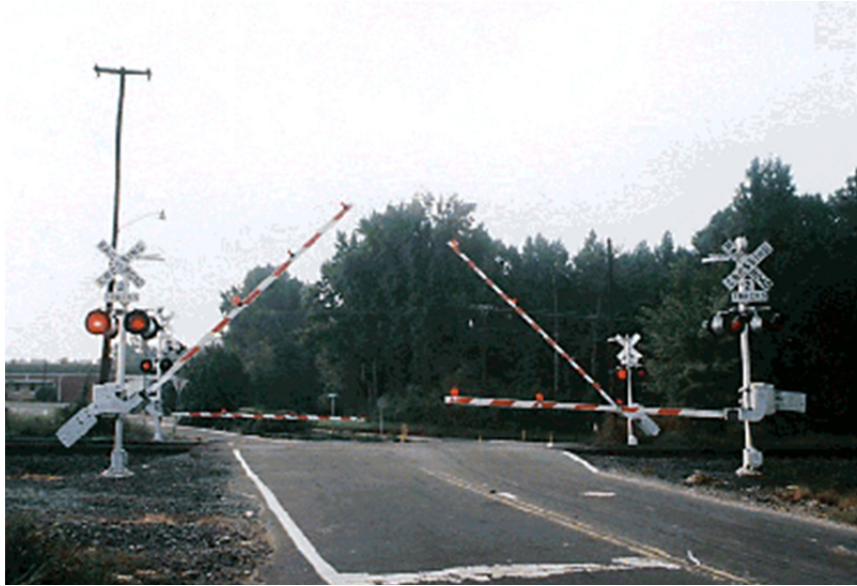
Figure 11: Example of Four-Quadrant Gate System

Left: A four-quadrant gate in North Carolina (note: the gates to the entrances are already closed, but the gates for the exits are in the process of closing). (Source: North Carolina Department of Transportation)

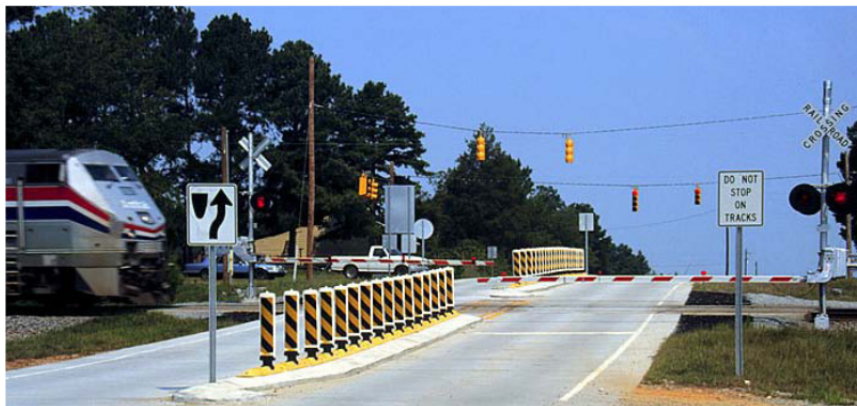
Figure 12: Example of Mountable Raised Curb Channelization Device

*Left: A mountable raised curb with vertical panels in North Carolina.
(Source: North Carolina Department of Transportation)*

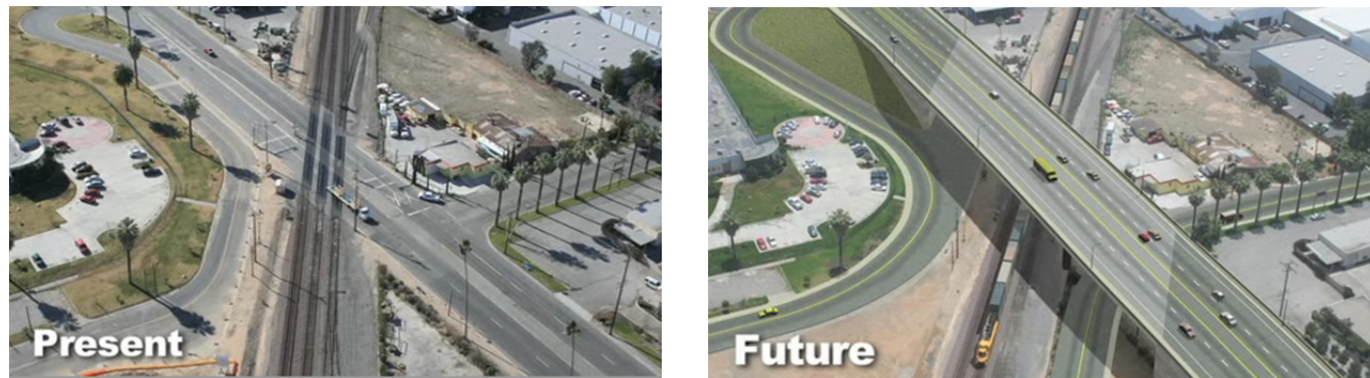
Figure 13: Example of Road over Rail Grade Separation Project

Left: Present conditions at Iowa Avenue in Riverside, CA. Right: A rendering of a planned roadway bridge over the railroad tracks. (Source: Riverside California, Public Works Department)

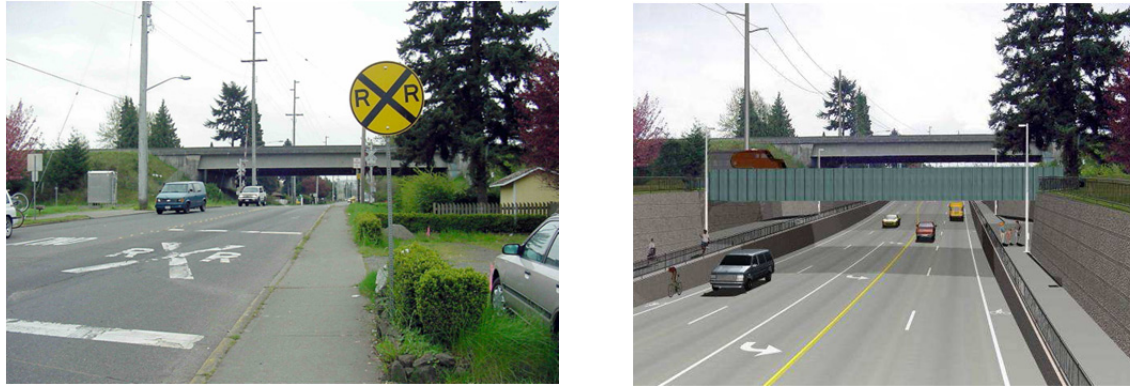
Figure 14: Example of Road under Rail Grade Separation Project

Left: Present at-grade conditions at M Street in Auburn, WA. Right: A rendering of a planned roadway tunnel under the rail line in Auburn, WA. (Source: Puget Sound Regional Council)

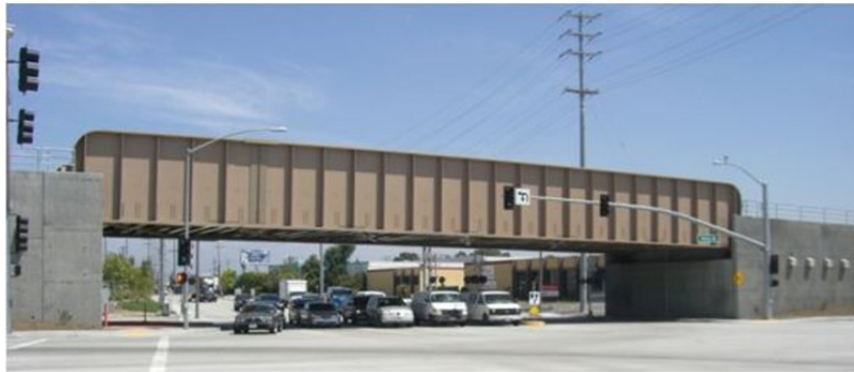
Figure 15: Example of a Rail over Road Grade Separation Project

*A railroad bridge over Sunset Avenue
in the City of Industry, CA.
(Source: Alameda Corridor-East
Construction Authority)*
